**MARYLAND HISTORICAL TRUST
DETERMINATION OF ELIGIBILITY FORM**

Property Name: Building 234NS Inventory Number: AA-2427
Address: Halligan Road Naval Support Activity Annapolis, North Severn Complex Historic district: yes ☒ no
City: Annapolis Zip Code: 21402 County: Anne Arundel
USGS Quadrangle(s): Annapolis
Property Owner: United States Navy Tax Account ID Number: _____
Tax Map Parcel Number(s): _____ Tax Map Number: _____
Project: Contract N40080-07-D-0311, Delivery Order 40 Agency: NAVFAC Washington
Agency Prepared By: The Louis Berger Group, Inc
Preparer's Name: Patti Kuhn Date Prepared: 7/20/2010
Documentation is presented in: _____
Preparer's Eligibility Recommendation: _____ Eligibility recommended ☒ Eligibility not recommended
Criteria: A B C D Considerations: A B C D E F G
Complete if the property is a contributing or non-contributing resource to a NR district/property:
Name of the District/Property: _____
Inventory Number: _____ Eligible: yes Listed: yes
Site visit by MHT Staff yes ☒ no Name: _____ Date: _____

Building 234NS

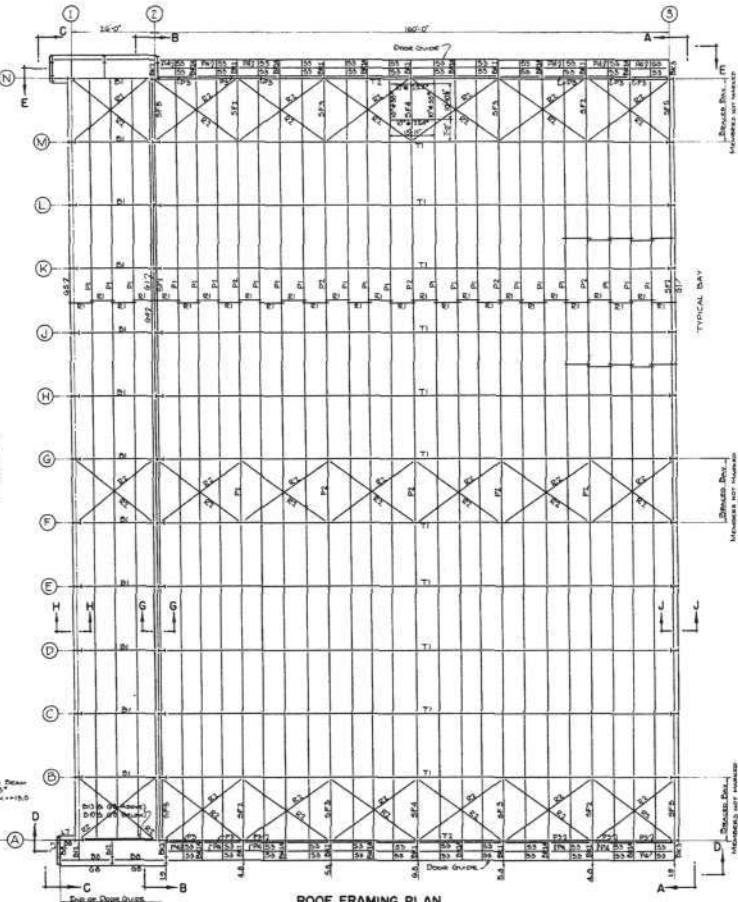
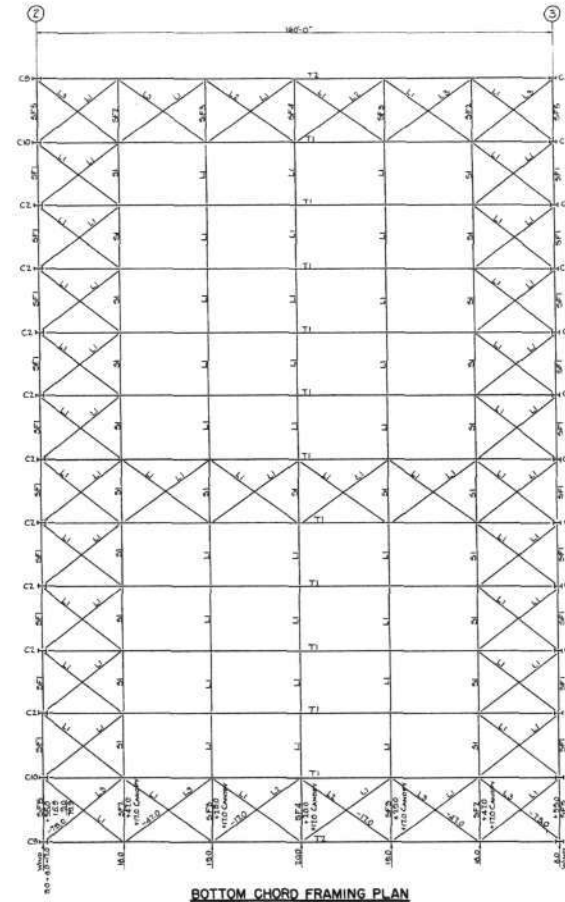
U. S. NAVAL ACADEMY
ANNAPOLIS, MD.
AVIATION FACILITIES
SEAPLANE HANGAR
SECOND FLOOR, ROOF & BOTTOM
CHORD FRAMING PLAN

SECOND FLOOR FRAMING PLAN

ROOF FRAMING PLAN

END ELEVATION

SECTION M-M

BOTTOM CHORD FRAMING PLAN

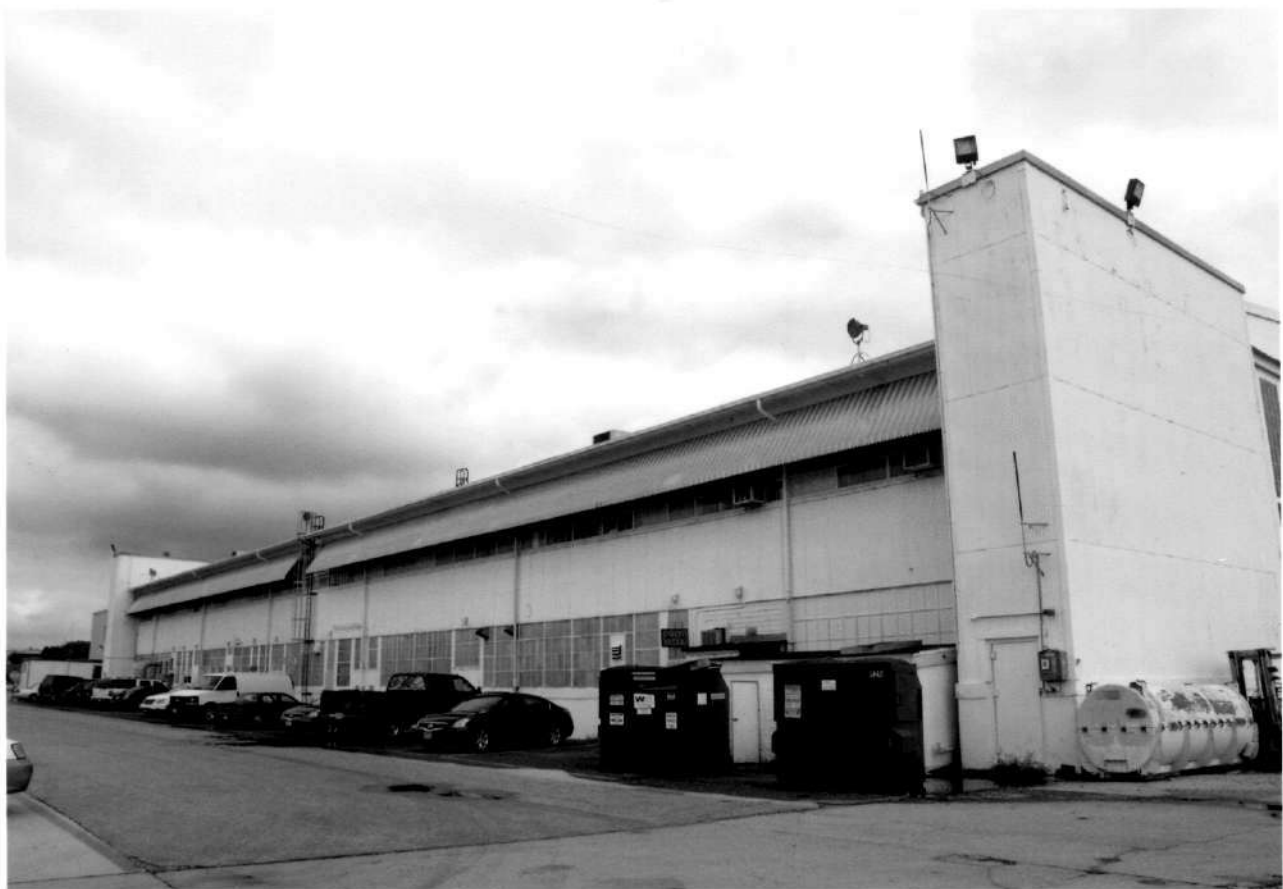
PHOTO 1 OF 6

The north elevation of the building is lined with two continuous rows of multi-light metal-sash industrial windows. The lower level of windows has a concrete sill. The north elevation originally had three one-story lean-to sheds. The westernmost shed served as a heater and boiler building, and the adjacent shed held the oil tank. The oil-tank shed has been demolished, revealing stretcher-bond brick on the north elevation of the former hangar and the east elevation of the adjacent heater building. The use of brick most likely indicates that the oil tank shed was built to be fireproof. The third heater lean-to, located near the east side of the north elevation, has been demolished; a brick section of wall on the north elevation of the former hangar indicates its former location. A second lean-to used as a heater building is located near the center of the building, and a propane storage shelter is located on its east side. The extant lean-to sheds are clad in corrugated metal and have corrugated shed roofs.

NORTH ELEVATION, LOOKING SOUTHEAST

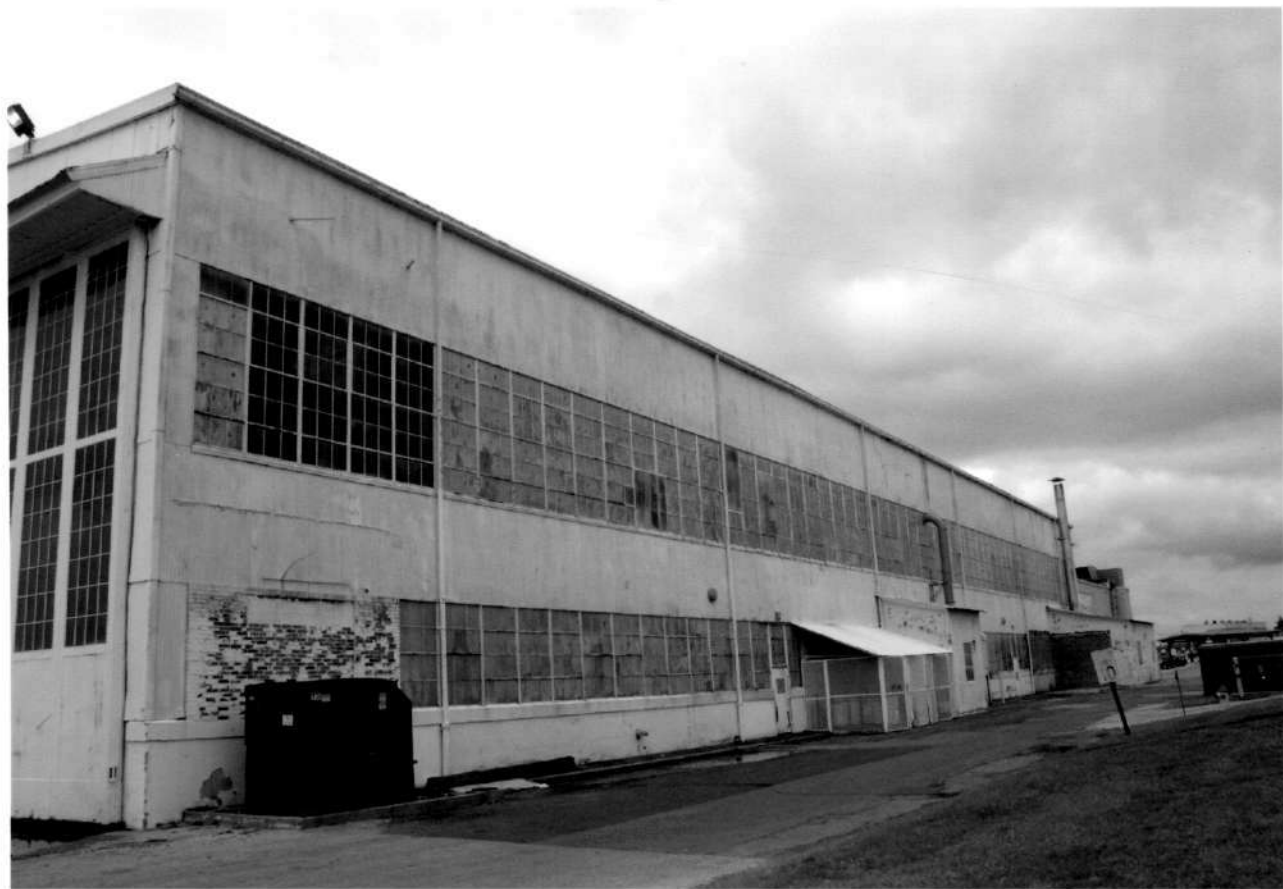
PHOTO 2 OF 6

NORTH ELEVATION, LOOKING WEST

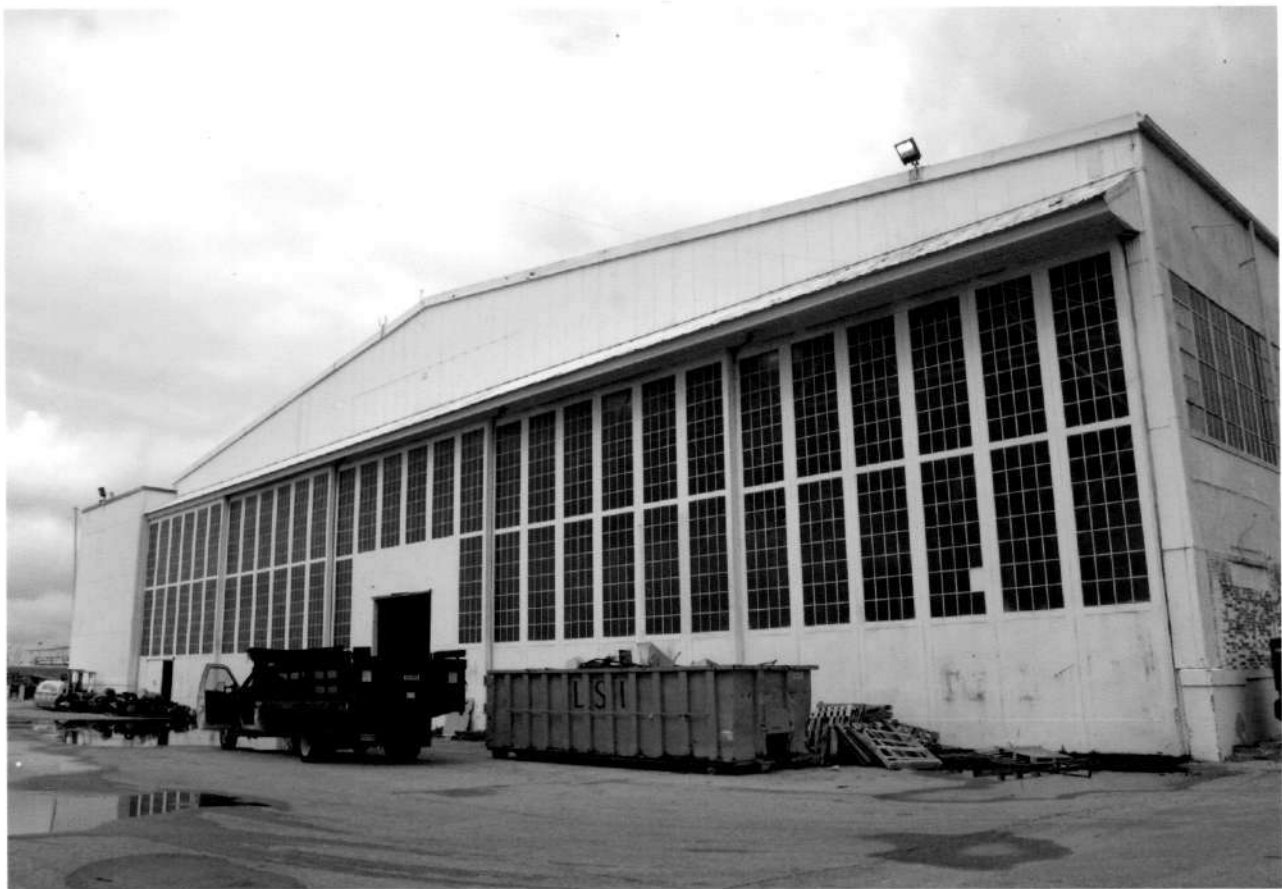
PHOTO 3 OF 6

The east elevation of the building has two rows of vertical four-by-seven-light metal-sash windows. Below the lower row of windows, the exterior wall is clad in metal panels. A pent-roof metal awning lines the elevation above the upper row of windows. The center bay of the elevation consists of a large full-height sliding door that has been pierced with a central opening. It is unclear if the central opening is original; however, it was most likely created to avoid using the large sliding door. An additional, smaller sliding metal door is located south of the center door.

EAST ELEVATION, LOOKING SOUTHWEST

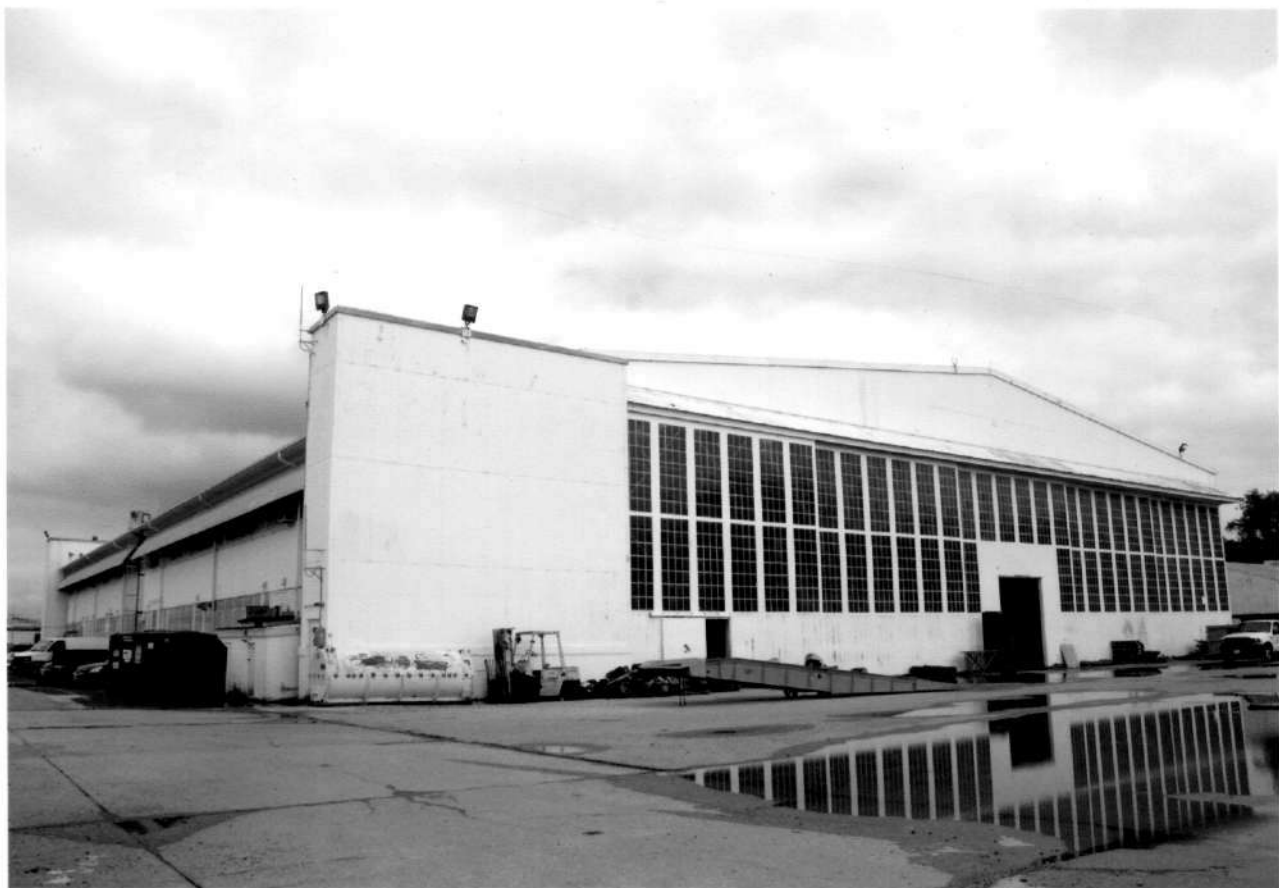
PHOTO 4 OF 6

The south elevation of the former hangar is lined with a two-story office wing that has a corrugated metal shed roof. The first and second stories are pierced by continuous rows of multi-light metal-sash windows. The row of windows on the first story has a concrete sill and is intermittently broken by single-leaf and double-leaf metal replacement doors. The row of windows on the second story is sheltered by a continuous metal awning. In between the rows of windows, the exterior wall is clad in metal panels. Clerestory windows line the south elevation of the building above the office wing.

EAST & SOUTH ELEVATIONS, LOOKING NORTHEAST

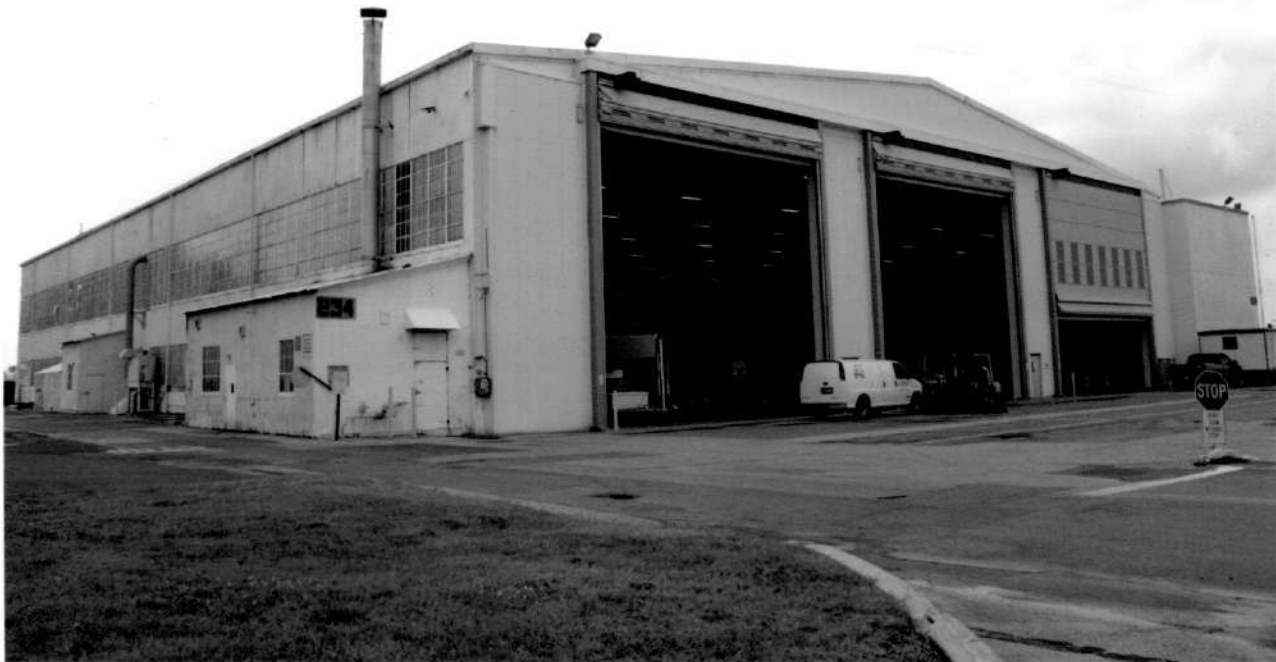
PHOTO 5 OF 6

The original west elevation of the building was completely removed circa 2000. Historically, the west elevation was similar to the east elevation with a large center sliding door and two rows of windows. Currently, the northwest elevation has three large full-height openings with canvas roll-up doors. The siding on the west elevation has been replaced with new corrugated metal.

WEST ELEVATION, LOOKING SOUTHEAST

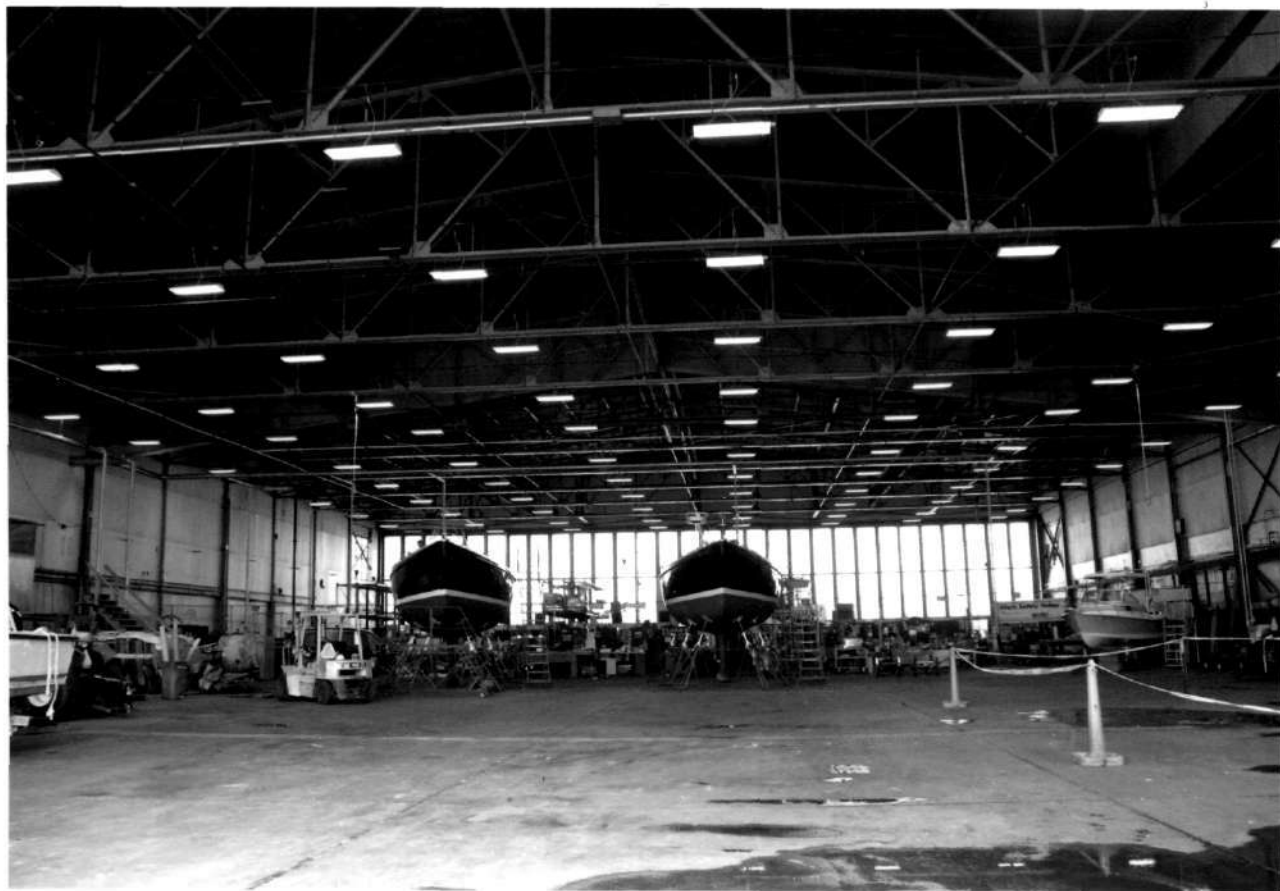
PHOTO 6 OF 6

The interior of the building is a large open space now used for repairing sailing craft. A small section of the east side of the interior is fenced and contains supply materials for the Naval Academy. The south section of the building holds offices on the first story. The ceiling is exposed, showing the metal roof trusses and wood ceiling panels. Historically, the two-story office wing held several small rooms on each floor that included offices, a ready room, an electric shop, a radio shop, a flight gear locker, and a parachute well (Naval Academy Archives 1952).

INTERIOR OF BUILDING 6
